Kyiv School of Economics  
Faculty of Social Sciences  
Urban Studies and Postwar Reconstruction

**Material Identity of Kyiv: Restoring the Historic Character of the City through  
the Restoration of 19th- and Early 20th-Century Brick Architecture**

URB25

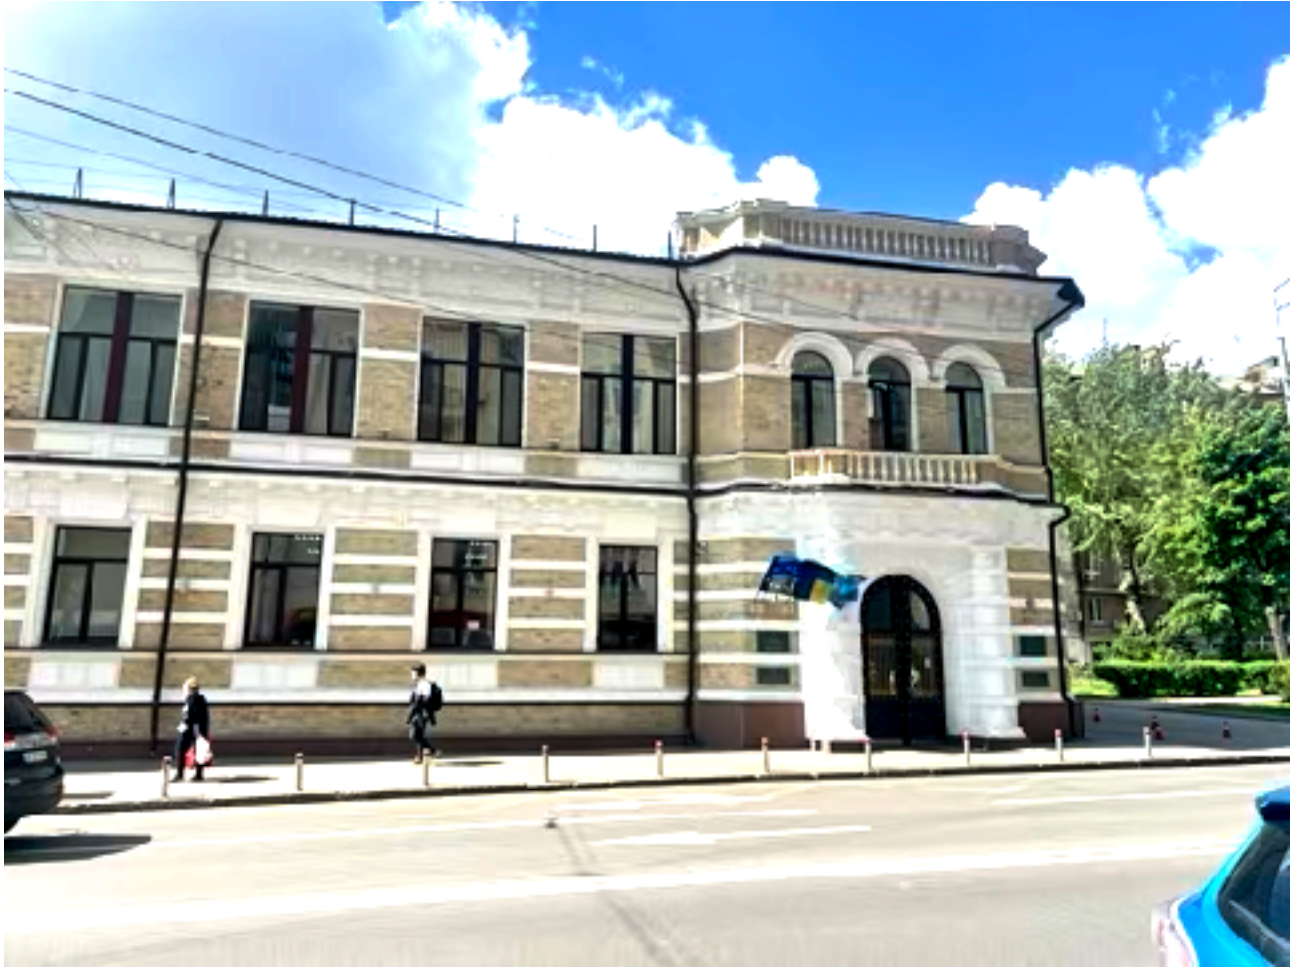
**Figure 3 – former gymnasium building at Bulvarno-Kudriavska Street 18/2**

The restoration process itself has revealed the extent to which restoration work can be difficult and uncertain. During the cleaning, the team has discovered up to seven layers of paint, including oil-based coatings, which were extremely difficult to remove without damaging the original brick surface. At the intermediate stages, the facade looked visually chaotic and damaged. The given moment is important, since it demonstrates that restoration often passes through phases where the building temporarily appears worse before the improvement becomes visible.

The case also demonstrates that exposed brick architecture possesses practical advantages in addition to historical value. According to the restoration team, exposed masonry is often capable of ageing more naturally than painted plaster facades, since it avoids constant cycles of peeling, cracking, and repainting. At the same time, facade restoration alone is not capable of solving deeper structural problems. Moisture penetration, damaged drainage systems, leaking roofs, and poor waterproofing remain serious threats for historic buildings throughout Kyiv. Therefore, the project demonstrates that restoration must be understood as a long-term and complex process, but not only as an aesthetic improvement.
