# Analysis of the Impact of the Kakhovka Hydroelectric Power Station Explosion

on the Populated Areas of Kherson and Mykolaiv Regions

KSE Institute

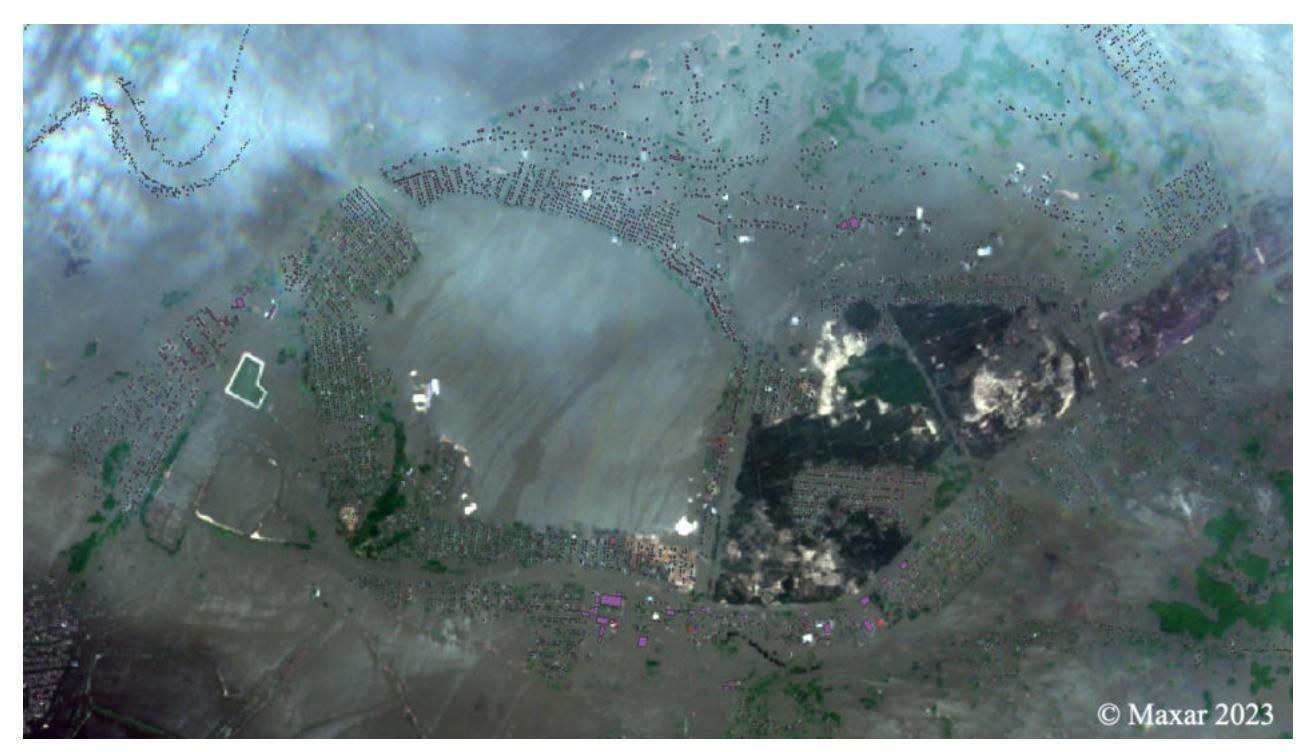
Image 1

During the analysis, satellite images from Sentinel-2 and Maxar, publicly available, were used to obtain visual information regarding the location and scale of the flooded areas. Instead of the original satellite imagery, this report will use descriptive references such as "Image 1", "Image 2" etc.

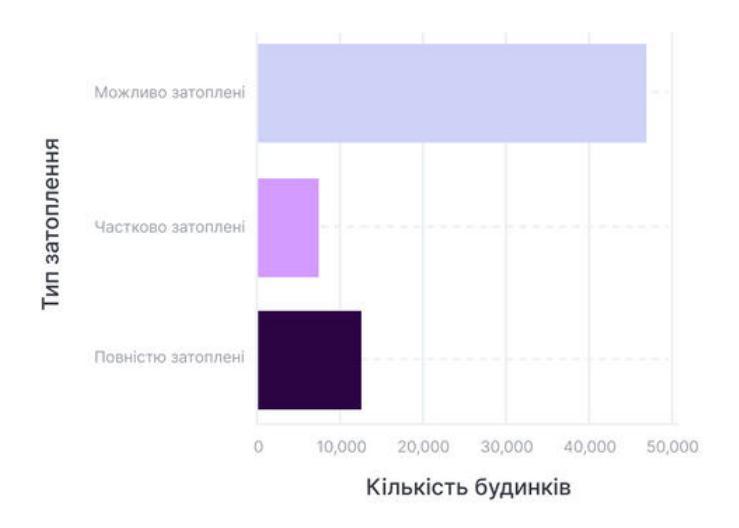
Using the building elevation data and height difference calculations, we determined the degree of inundation for each building and assigned them to the corresponding category. The flooded buildings were divided into four categories: fully flooded (flooding of 3 meters and above), partially flooded (flooding within the range of 1-3 meters), possibly flooded (flooding up to 1 meter), and not flooded. This classification provided us with detailed information about the degree of building inundation and allowed for a more accurate assessment of the damage in the affected communities.

## What does it look like in an infographic?

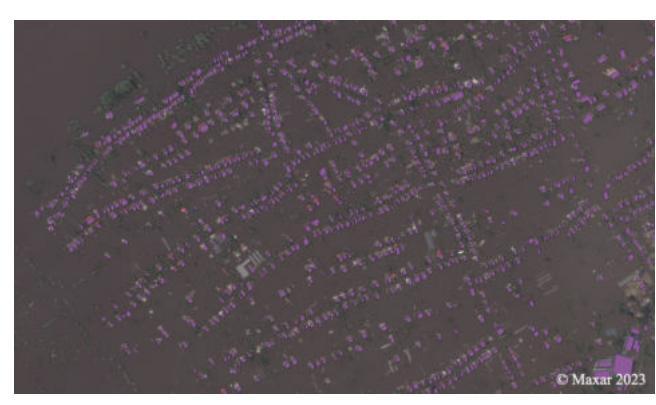
Image 1

Below are satelite images from Maxar, confirm the extent of the flooding and illustrate the distribution of flooded areas in different regions and districts (see Image 1, Image 2, Image 3).
